TO: Dill Customers

May 2, 2008

There have been recent reports of a concern with certain rubber snap-in valve stems manufactured under the Dill-ACP brand name and distributed by Dill Air Controls Products, LLC. As a result of recent reports and our investigation, we are advising of this concern affecting TR 413, TR 413 chrome, TR 414, and TR 418 Dill ACP valve stems.

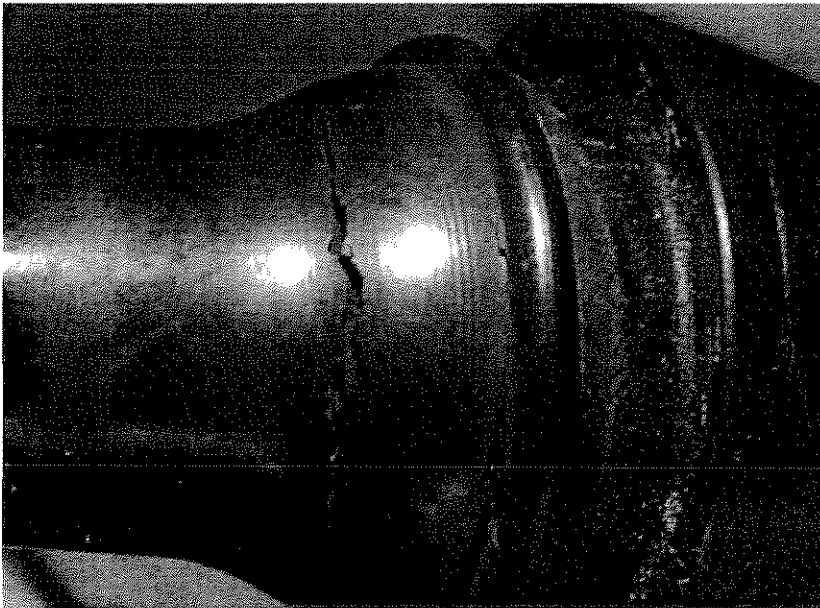
We have received a number of parts showing surface cracks on the outside of the rubber near the rim hole. Our initial investigation based on this anecdotal evidence has centered on ozone exposure. When the rubber is exposed to high levels of ozone as it is being stressed, surface cracks can appear. High speeds and an unsupportive rim profile allow the rubber valve to flex at a greater angle and may cause these cracks to propagate, leading to a slow leak of air.

2. Out of an abundance of caution, we are recommending that when customers return to your stores for regular service, you inspect the valves stems on vehicles who received valve stems during the period from September 2006 – June 2007. This can be done by flexing the valve in a clockwise direction around the rim and looking for cracks above the indicator ring of the valve, for example:

Those valve stems that contain visible surface cracks should be removed and replaced with a new valve stem. This affects the following stems:
